Freedom 21 – Modifications to Twin Lift Keel System

The twin lift keel modification to the Freedom 21 was installed on boats manufactured in the UK during the period 1984 - 89 and gave the boat a draft of 0.76m (2ft 6") keels down and 0.4m (1ft 4") keels up. However this ingenious twin keel lifting system has a number of inherent design problems that need to be addressed in order to make it a more practical and seaworthy arrangement and this article describes the modifications I made to my Freedom 21 DAYDREAM.

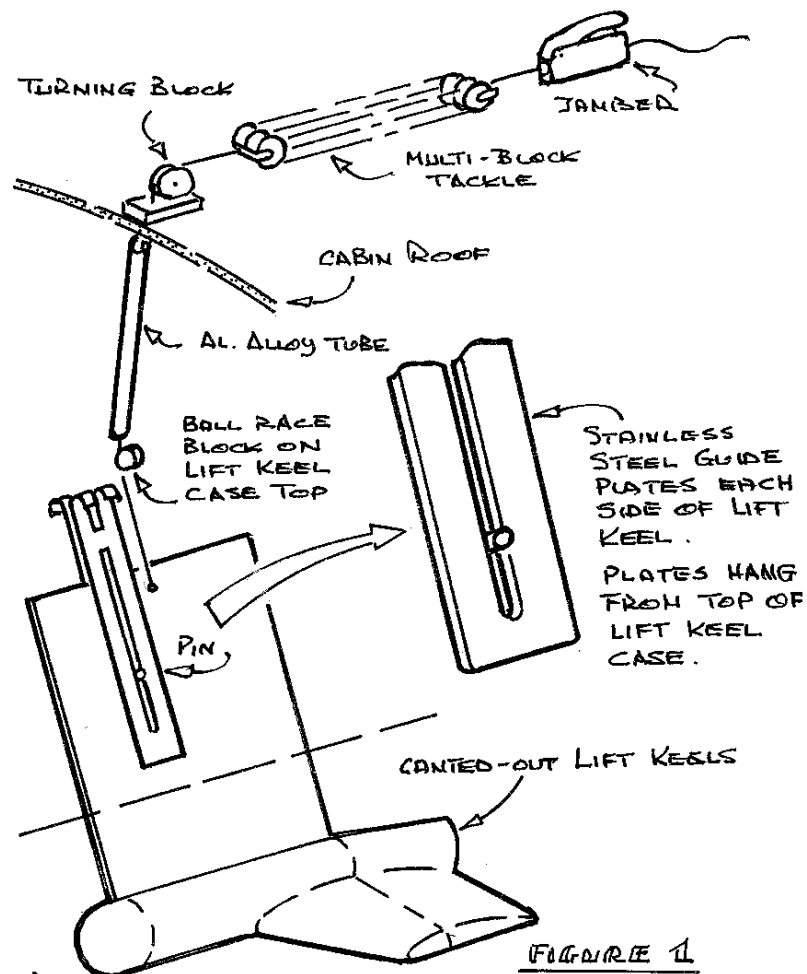
The lifting keels weigh about 260lb each and consist of a mild steel plate with a bolted-on cast iron, winged-keel bulb at the tip of the plate. The keels slot into fibreglass keel boxes which are moulded into the two raised table sections each side of the cabin between the main cabin bunks and the forward bulkhead. These keel boxes are canted outwards slightly and each keel box carries two stainless steel guide plates which fit each side of the keel plate and restricts keel plate movement by guiding a stainless steel pin, which is fitted to each of the keel plates and engages in a longitudinal slot in the guide plates – see **Figure 1**. These plates also act as a "stop" mechanism for the keels.

The keels are raised by a lifting line which is attached to the top of the keel and passes over a ball-race pulley fitted to the top of the keel box. This line passes up an aluminium alloy tube connecting the top of the keel box to the cabin roof, and then round a turning block fitted on top of the cabin roof and aft via a multi-block tackle system to the jamber clutches on each side of the sliding hatch. To lift the keels it is necessary to use the winches in conjunction with the jamber clutches, since even with low-friction pulleys in the system the loads are significant.

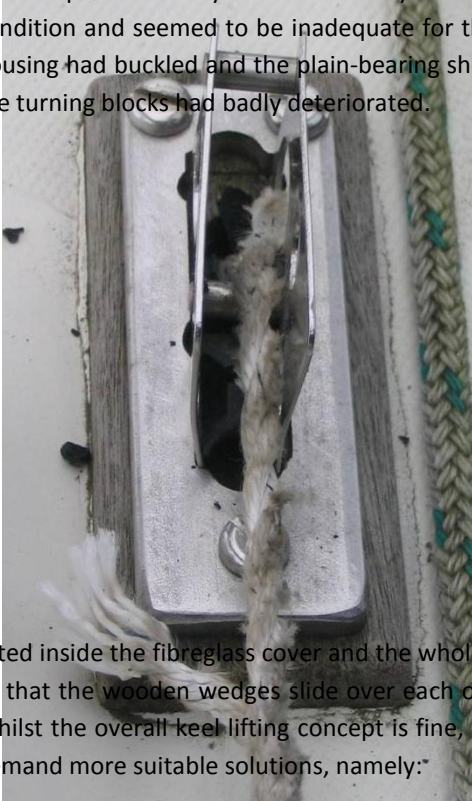
When I purchased my boat the surveyor noted that the turning blocks on the cabin roof were in a very poor condition and seemed to be inadequate for the loads involved, since on one of the blocks the thin stainless steel housing had buckled and the plain-bearing sheave had completely broken-up. Also the hardwood pads supporting the turning blocks had badly deteriorated.

fitted inside the fibreglass cover and the whole assembly is coated with a silicone sealer and assembled under load so that the wooden wedges slide over each other to form a solid packer when the silicone sealer has fully cured. Whilst the overall keel lifting concept is fine, this particular design has some fundamental practical problems that demand more suitable solutions, namely:

- *The hardwood pads under the cabin roof turning blocks were breaking-up & splitting under load.*
- *The cabin roof turning block units were buckling and the sheaves were breaking-up under load.*
- *Rainwater was entering the cabin through the aluminium tube where it connects to the turning block unit.*
- *It was impossible to examine the lifting-line connection to the top of the lifting keels and replace these without dismantling the whole assembly and dropping the keels out of the bottom of the boat.*
- *The lifting-line attachment to the lifting keel was not considered to be a secure arrangement.*
- *To remove the cabin roof liner the complete cabin roof turning block assembly had to be removed and the compression tube withdrawn.*
- *It was not possible to lift the “glued-in-place” fibreglass covers to examine the top of the keel box.*

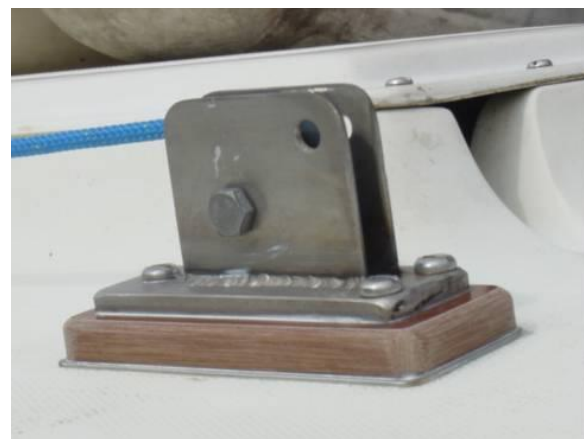
FIGURE 2

Cabin Roof Turning Block Problems: I made-up heavy-duty stainless steel welded mountings for the sheaves and installed 50mm (2”) dia. High-performance HARKEN 311 ball-race sheaves with a 2000lb safe working load. I replaced the hardwood pads supporting the turning block units with phenolic/cotton laminate (TUFNOL) to eliminate the weathering and deterioration problems associated with hardwood. And to avoid problems where the compression tube protrudes through the cabin roof moulding and bears on the underside of the TUFNOL block I fitted a thin stainless steel plate to handle these local bearing loads.

Rainwater Penetration Problem: To prevent the entry of rainwater into the cabin I made-up a pair of glass fibre/epoxy covers that are fitted over the turning block units and attached to the TUFNOL base pad with stainless steel self-tapping screws and silicone sealant. Note that drainage holes have been provided to prevent any build-up of water in the covers. Details of how these units were made are given in an article I published on the F21 site.

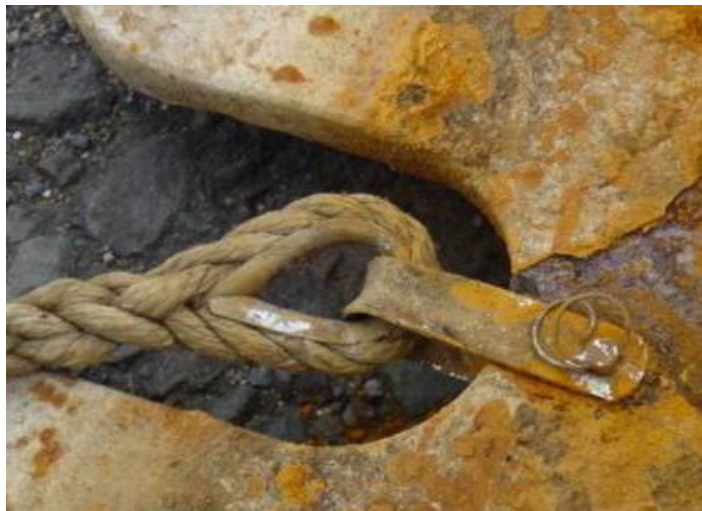
FIGURE 3

Lifting Line Attachment Problem: When the lifting keel units were removed it was evident that the method of lifting line attachment was really inadequate as it involved only a lightweight stainless

steel strap and a small diameter clevis pin attached with a stainless steel wire ring. It seemed likely that the stainless steel wire ring could fail and the stainless steel strap could then distort and disengage from the clevis pin, leaving only the guide plate system to prevent the keel from falling out of the keel box. The system used to replace this arrangement is shown in concept form in **Figure 3**.

In this design the lifting line locates over pin **B** which is integral with plate **A** that is welded to the keel plate. A removable plate **C** is then fitted to prevent the lifting line coming off the pin. The whole assembly is locked in position with a stainless steel "R" clip.

The key "fail-safe" feature of this design is that even if the "R" clip is removed, plate **C** cannot disengage from the lifting keel, since it has two long retaining pins, which pass completely through the keel plate, so that the removable plate cannot physically disengage from the keel plate – there is just not enough space within the keel box to allow this. Plate **C** can only be removed when the lifting keel is fully raised and supported and a hatch is opened in the side of the keel box to gain access. This design enables one to gain access to the lifting line fixing point and replace a worn line without dismantling the whole assembly and without dropping the keels out of the boat.

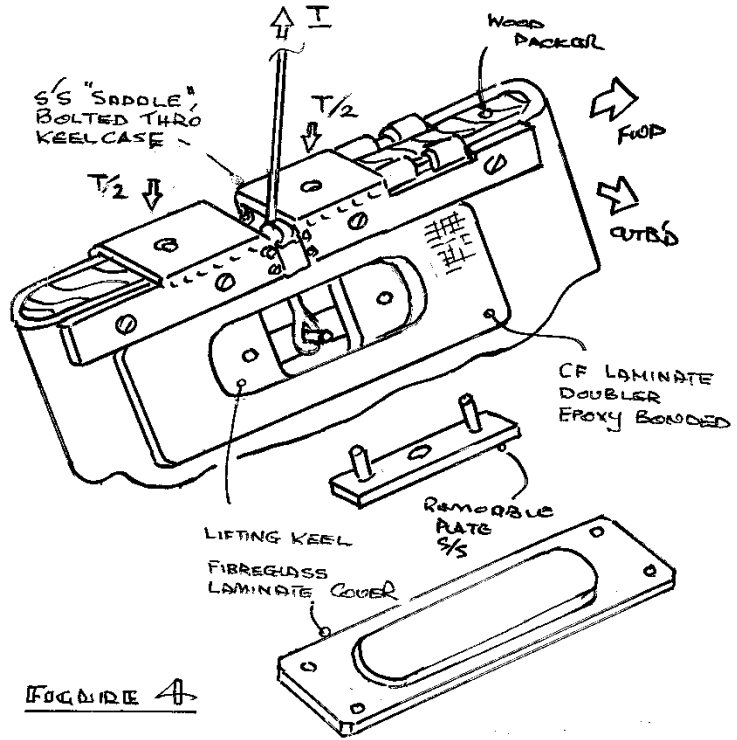
Lifting Line Replacement Problem: The solution to this problem was to cut a hatch in the outboard, upper side of each keel box and reinforce this cut-out with an epoxy bonded CF laminate doubler – **Figure 4.** This hatch allows clear access to the lifting line attachment point when the keels are raised and supported, as would occur when the boat “dries out” with keels raised or is on its road trailer. The hatch is closed with a fibre glass laminate cover that has a doubler region that corresponds to the cut-out zone and restores the inner face of the keel case when the cover is bolted in place. The cover is bolted in place with stainless steel set-screws that locate in stainless steel tapped plates laminated into the CF laminate doubler. When the cover is bolted in place a smear of grease on all mating faces creates a watertight seal.

The tension in the lifting line **I** is reacted by the compression tube linking the keel box to the cabin roof moulding and the load passes down into the keel box through the stainless steel “saddle” unit that is bolted through the top of the keel box and the wooden packers inside the top of the keel box. This arrangement makes replacement of the lifting line a simple operation.

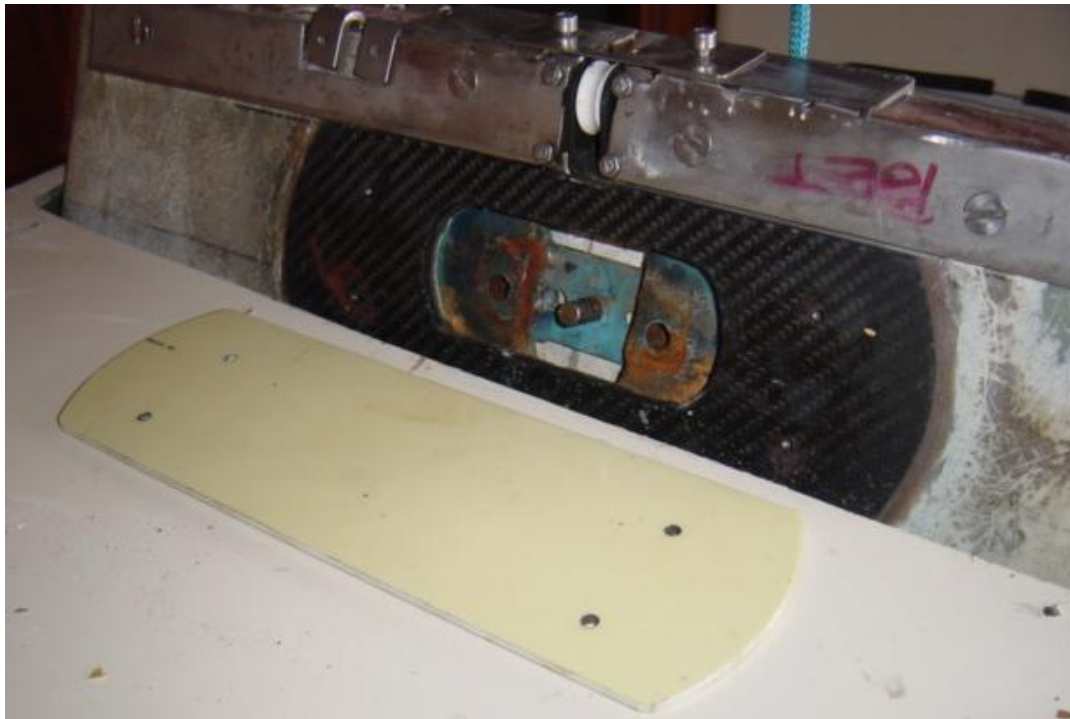
FIGURE 5

Replacement of Lifting Line: The lifting lines can be easily replaced when the keels are raised and supported as follows – see **Figure 5**:

1. *The lifting line is slackened-off and disconnected from the multi-part tackle on the cabin roof.*
2. *The fibreglass cover is removed from the turning block on the cabin roof.*
3. *The stainless steel tube is unbolted from “saddle” capping-plate and can then slide-off the “saddle” capping-plate and be disengaged from the socket hole in the roof of the cabin.*
4. *The end of the lifting line is passed down through the cabin roof and through the stainless steel tube.*
5. *The keel box cover is removed, the “R” clip is withdrawn and the removable plate disengaged to allow the lifting line to be removed.*
6. *The replacement lifting line is fitted and the above procedure is reversed – it is helpful to use a thin cord feeder line to pull the lifting line back up the stainless steel tube and through the turning block assembly.*

In this revised design the cosmetic fibre glass cover for the top of the keel box takes none of the compression load in the stainless steel tube and this load is distributed directly into the keel case through the stainless steel “saddle” capping-plate which is securely through-bolted to the top of the keel box. The 5mm (0.2”) thick carbon fibre doubler reinforcement around the cut-out in the keel box is more than adequate to carry the compression loads around the cut-out and into the keel box.

When unbolted from the “saddle” capping-plate the stainless steel compression tube easily slides-out and can be disconnected from the lifting line. The replacement of the small diameter aluminium alloy tube with a large diameter (38mm – 1.5”) stainless steel tube allows the end spliced eyes of the lifting line to pass through the tube with no problems. Also the larger diameter hole in the turning block base allows the lifting line eyes to pass through this unit easily.
